Andrew J. Meyers
County Attorney

OFFICE OF THE COUNTY ATTORNEY
115 S. Andrews Avenue, Suite 423
Fort Lauderdale, Florida 33301

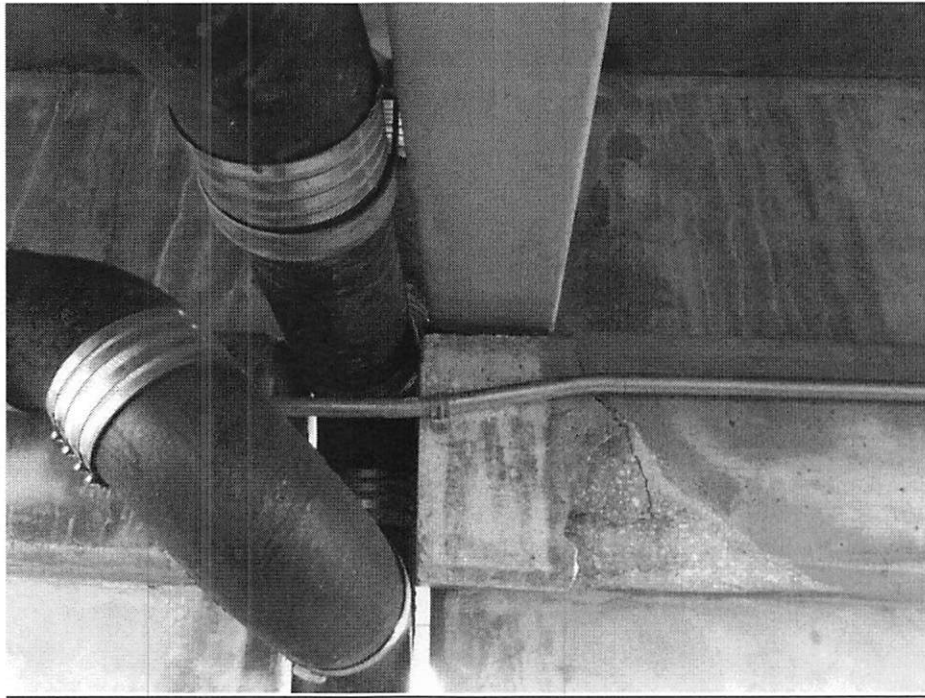
Exhibit 1: Cracked Haunch below third floor joist.

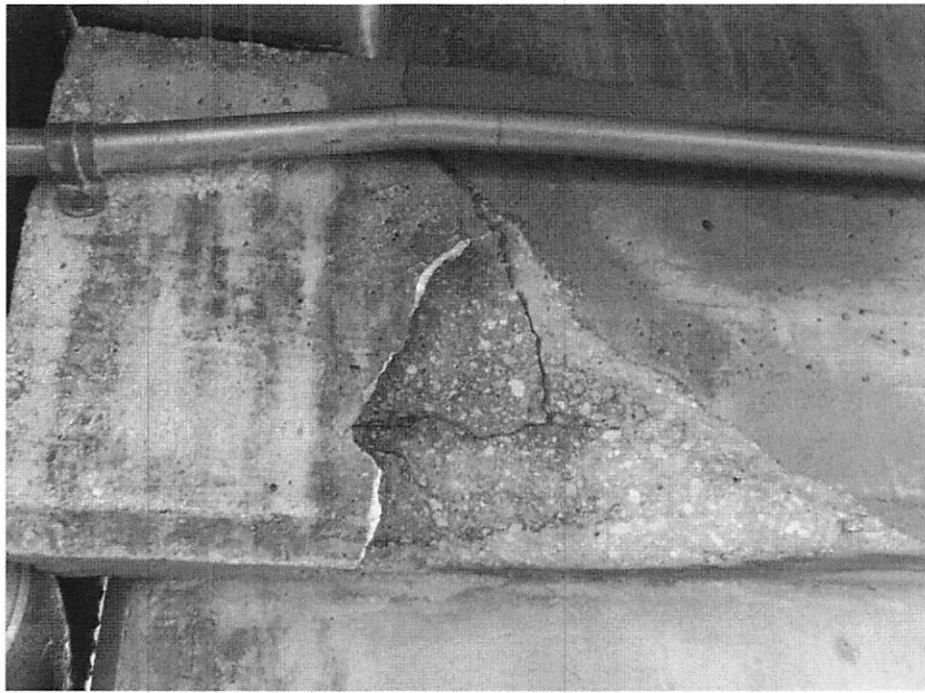
Exhibit 2: Cracked Haunch below third floor joist. No stirrups found in this area.

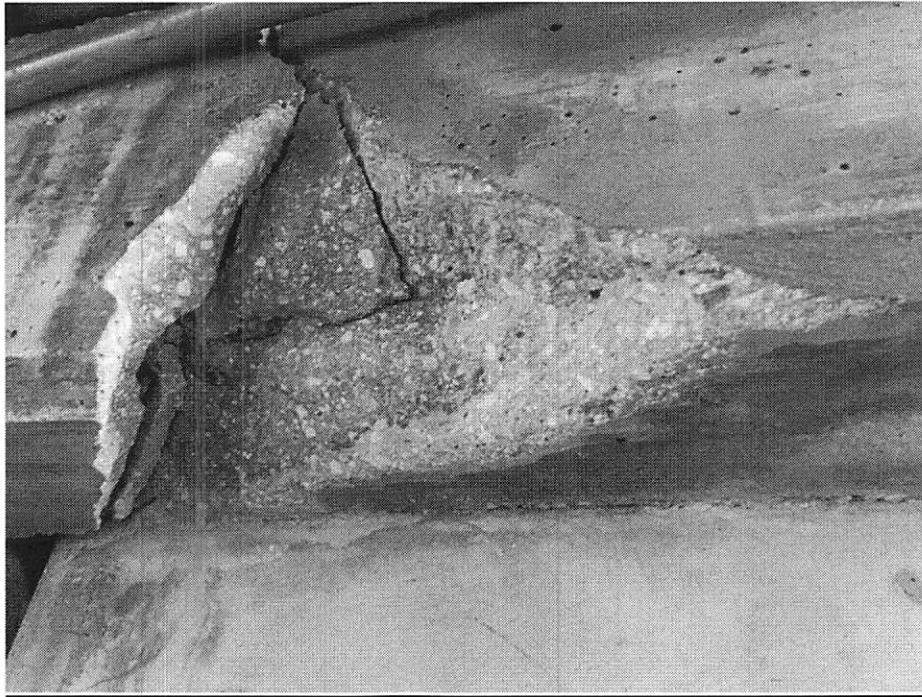
Exhibit 3: Cracked Haunch below third floor joist – No longitudinal rebar found here.

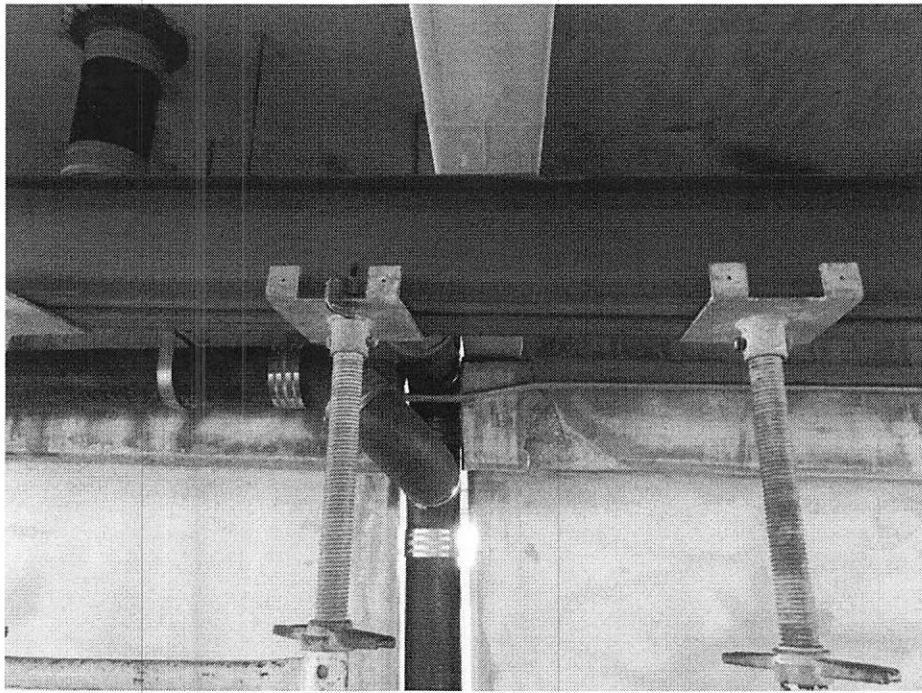
Exhibit 4: Cracked Haunch and Shored Joist below third floor.

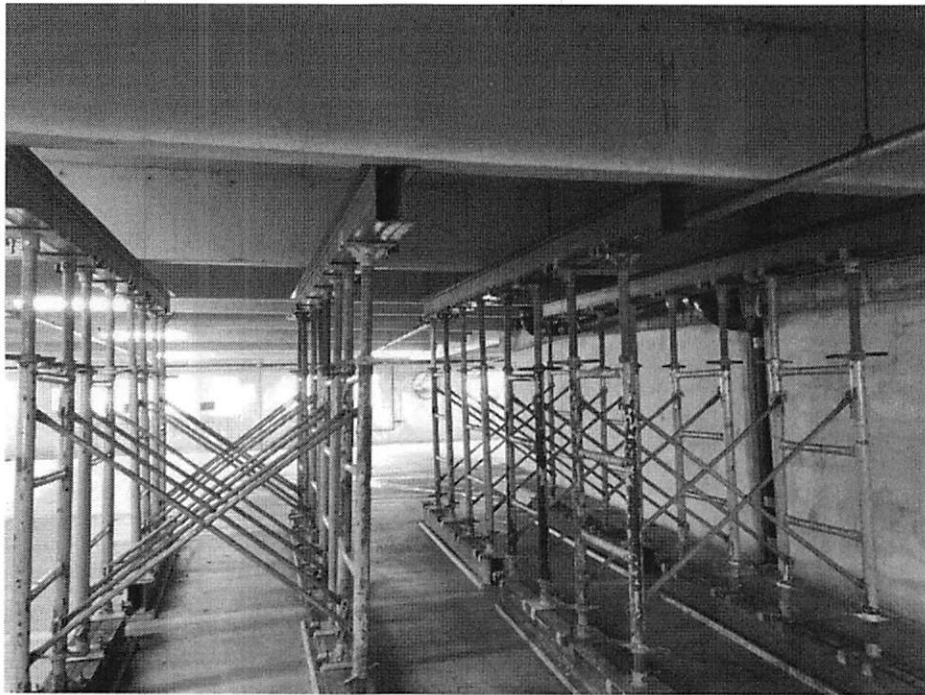
Exhibit 5: Overall view of the shoring on second floor.

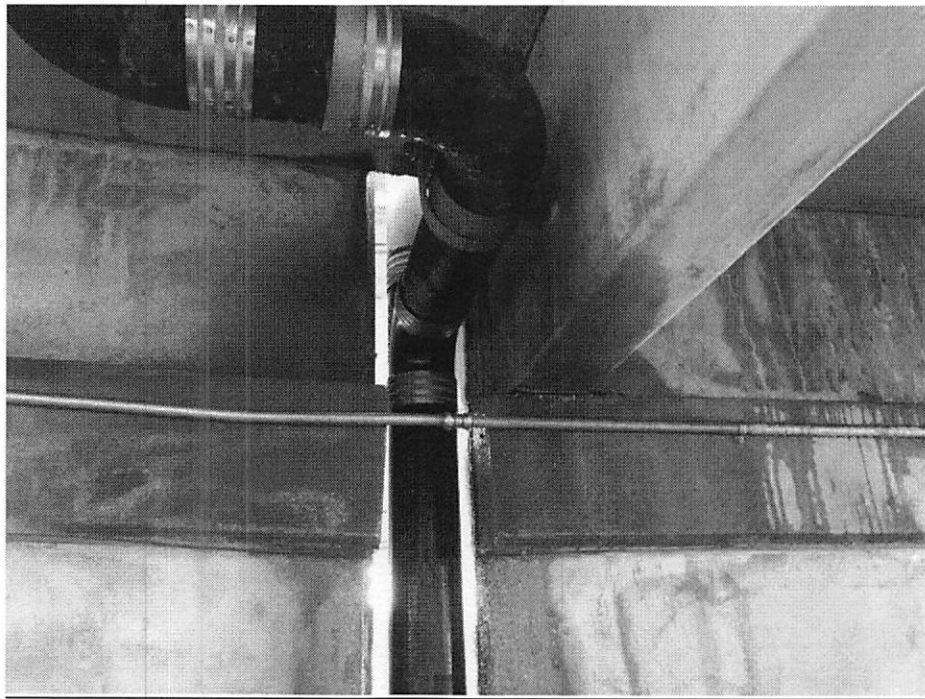
Exhibit 9: Condition where a third floor joist is at the edge of a haunch. Shoring is required here.

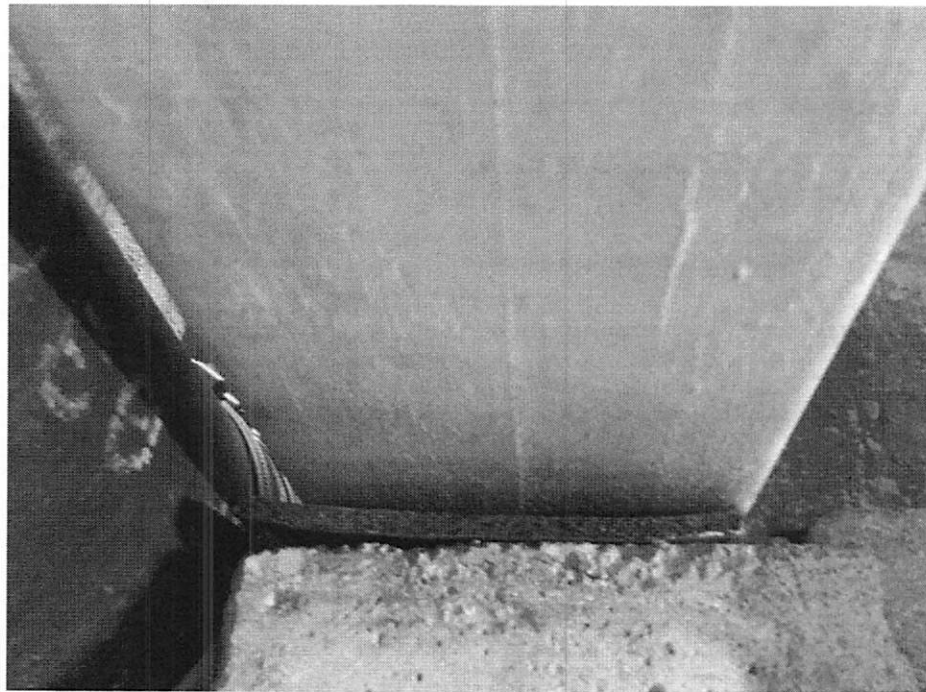
Exhibit 10: Loose bearing pad. Joist is not bearing on the front half of the cracked haunch.

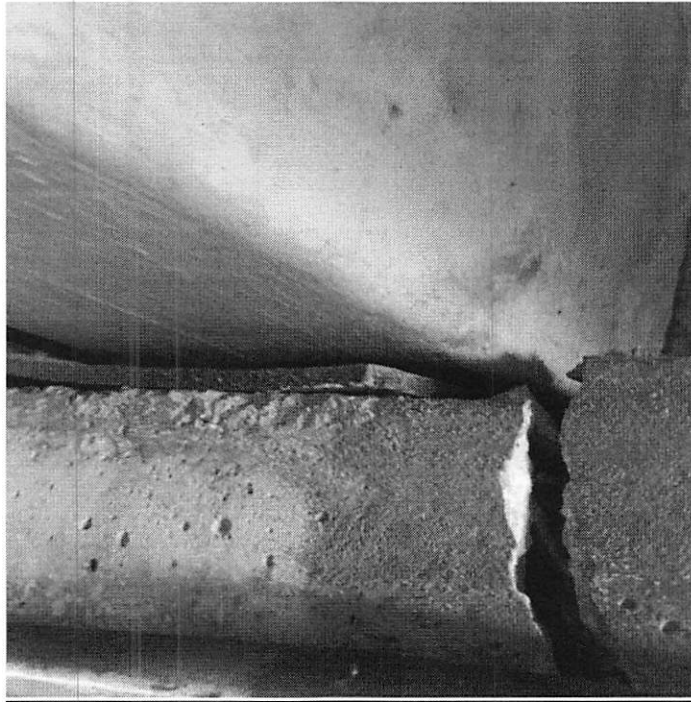
Exhibit 11: Loose bearing pad. Joist is not bearing on the front half of the cracked haunch.

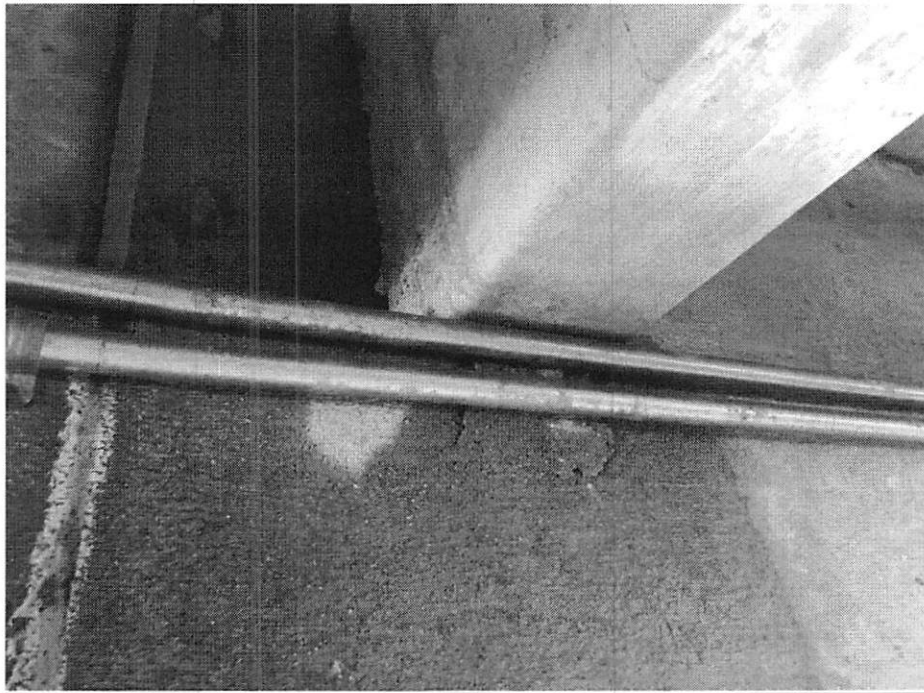
Exhibit 12: Spalled face of a haunch below a supported joist.

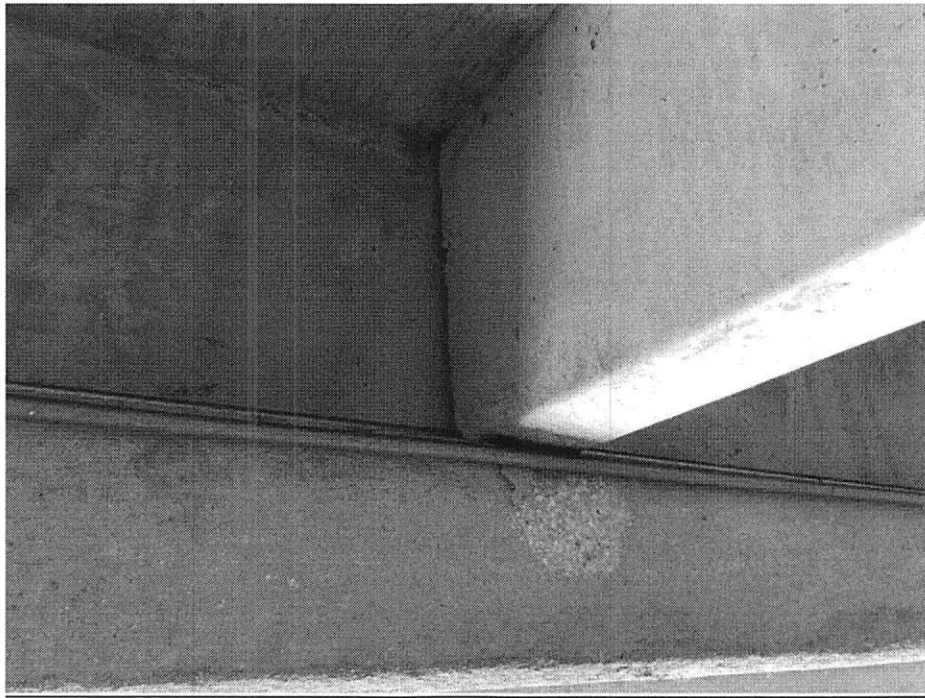
Exhibit 13: Spalled face of a haunch below a supported joist.

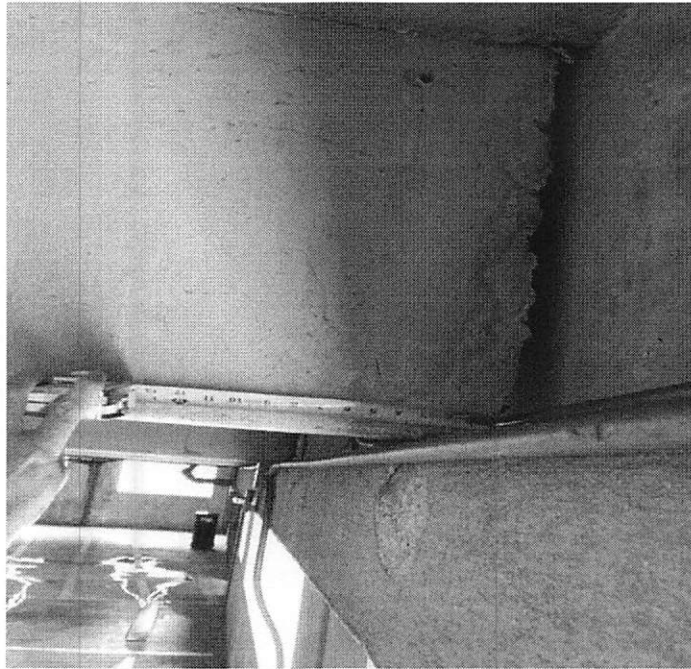
Exhibit 14: Spalled face of a haunch below a supported joist.

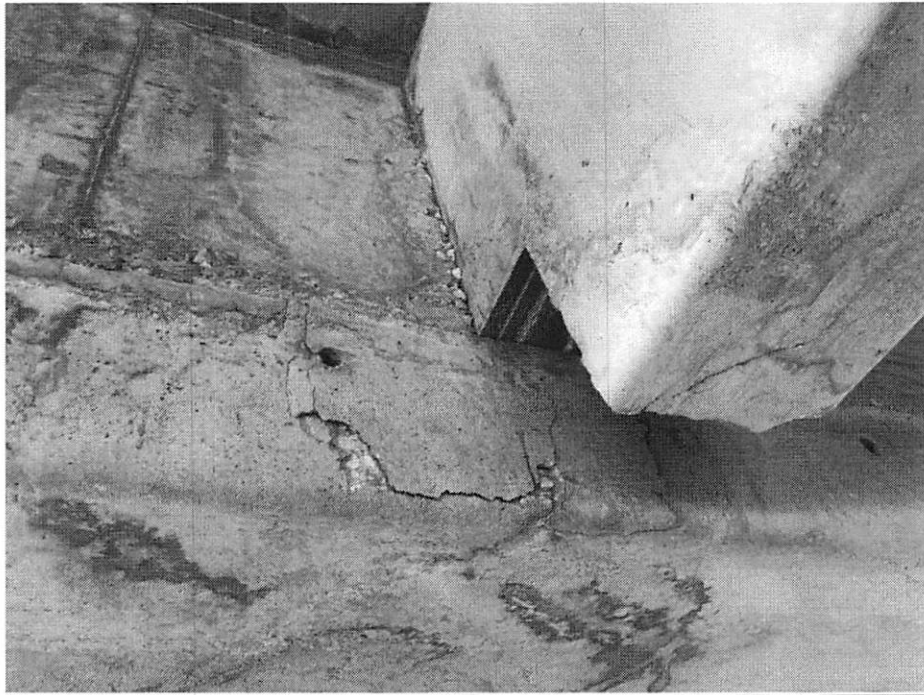
Exhibit 15: Spalling and Cracking on a soffit beam at a joist support.

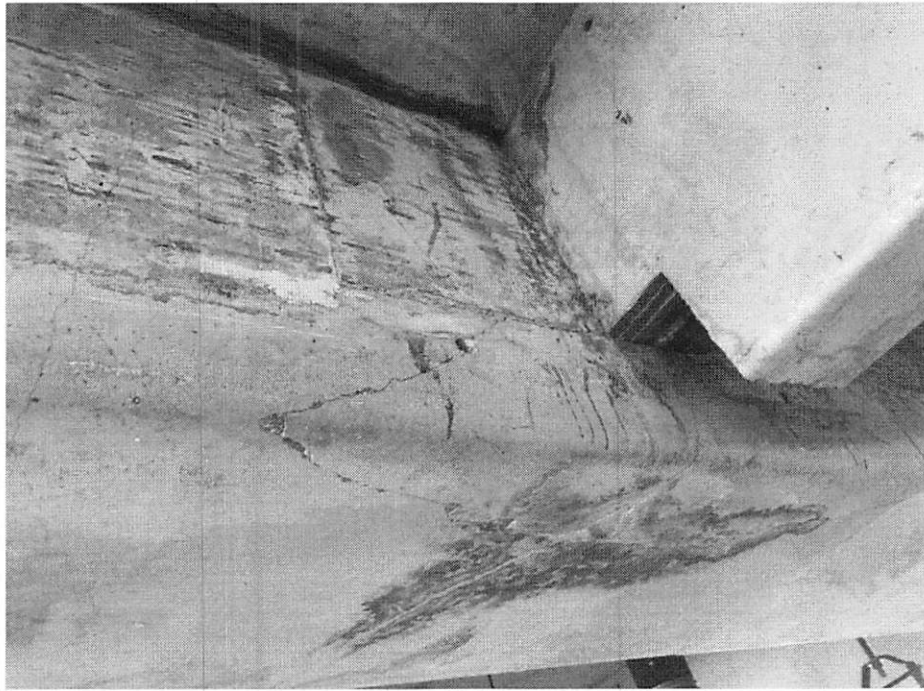
Exhibit 16: Spalling and Cracking on a soffit beam at a joist support.

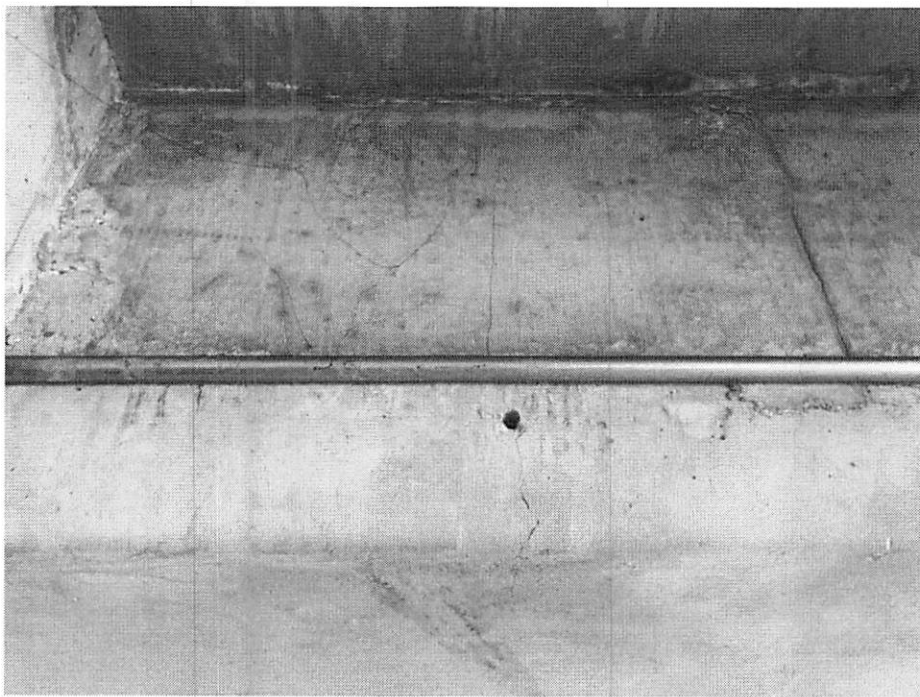
Exhibit 17: Vertical and diagonal cracks on a soffit beam.

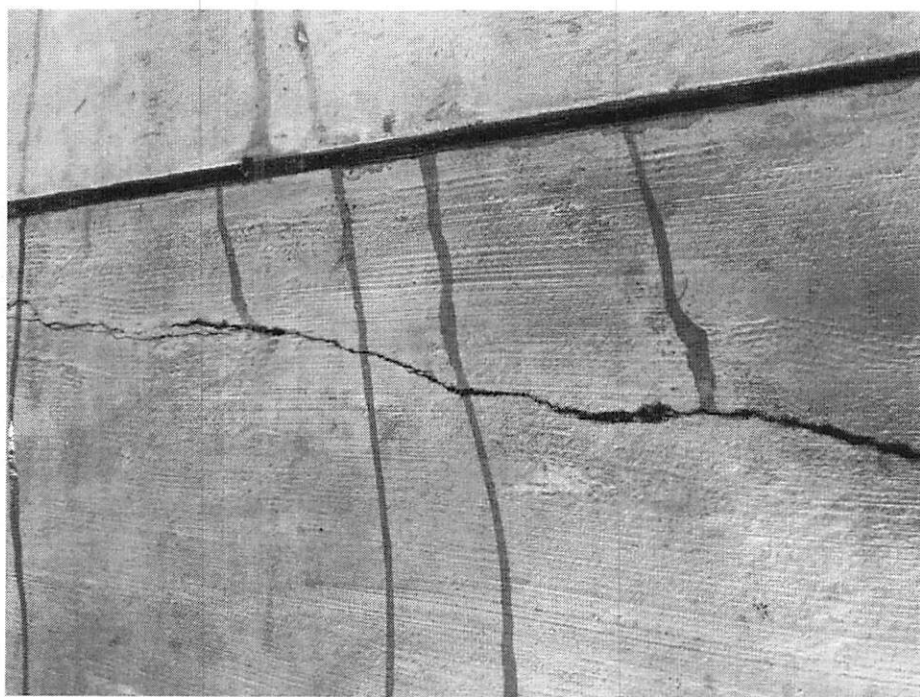
Exhibit 18: Slab cracks along the sides of a soffit beam.

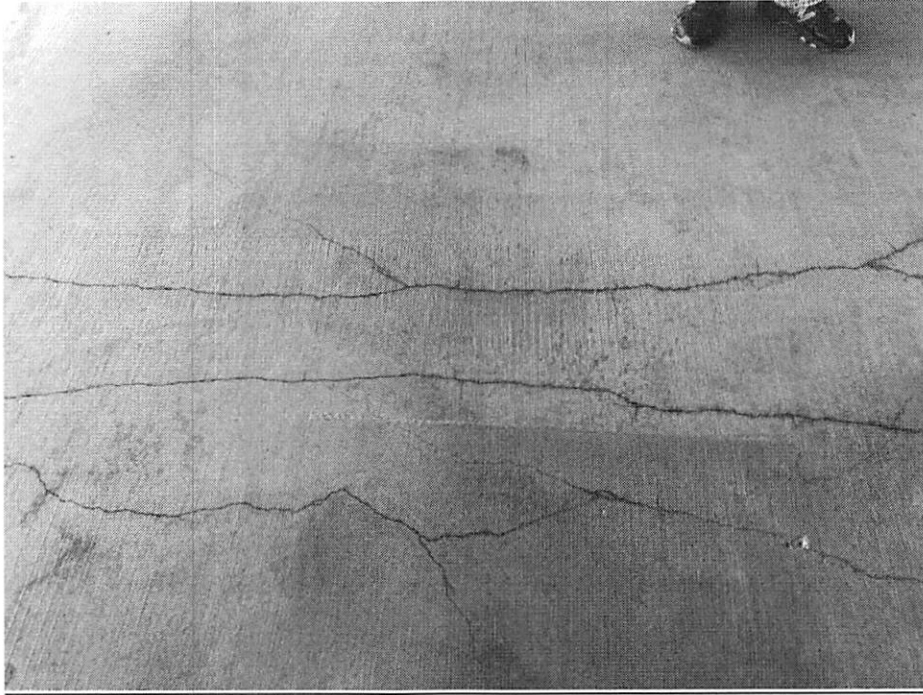
Exhibit 19: Slab cracks along the sides of a soffit beam.

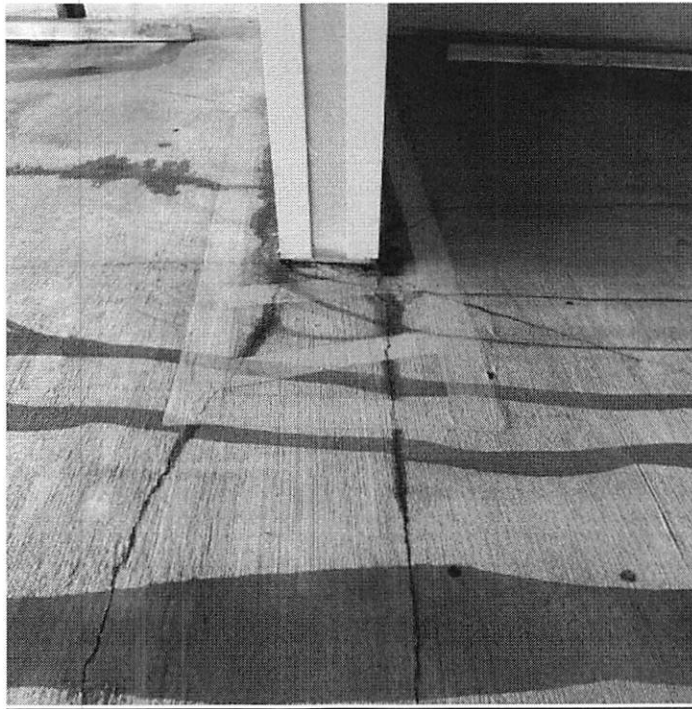
Exhibit 20: Slab cracks along the sides of a soffit beam.

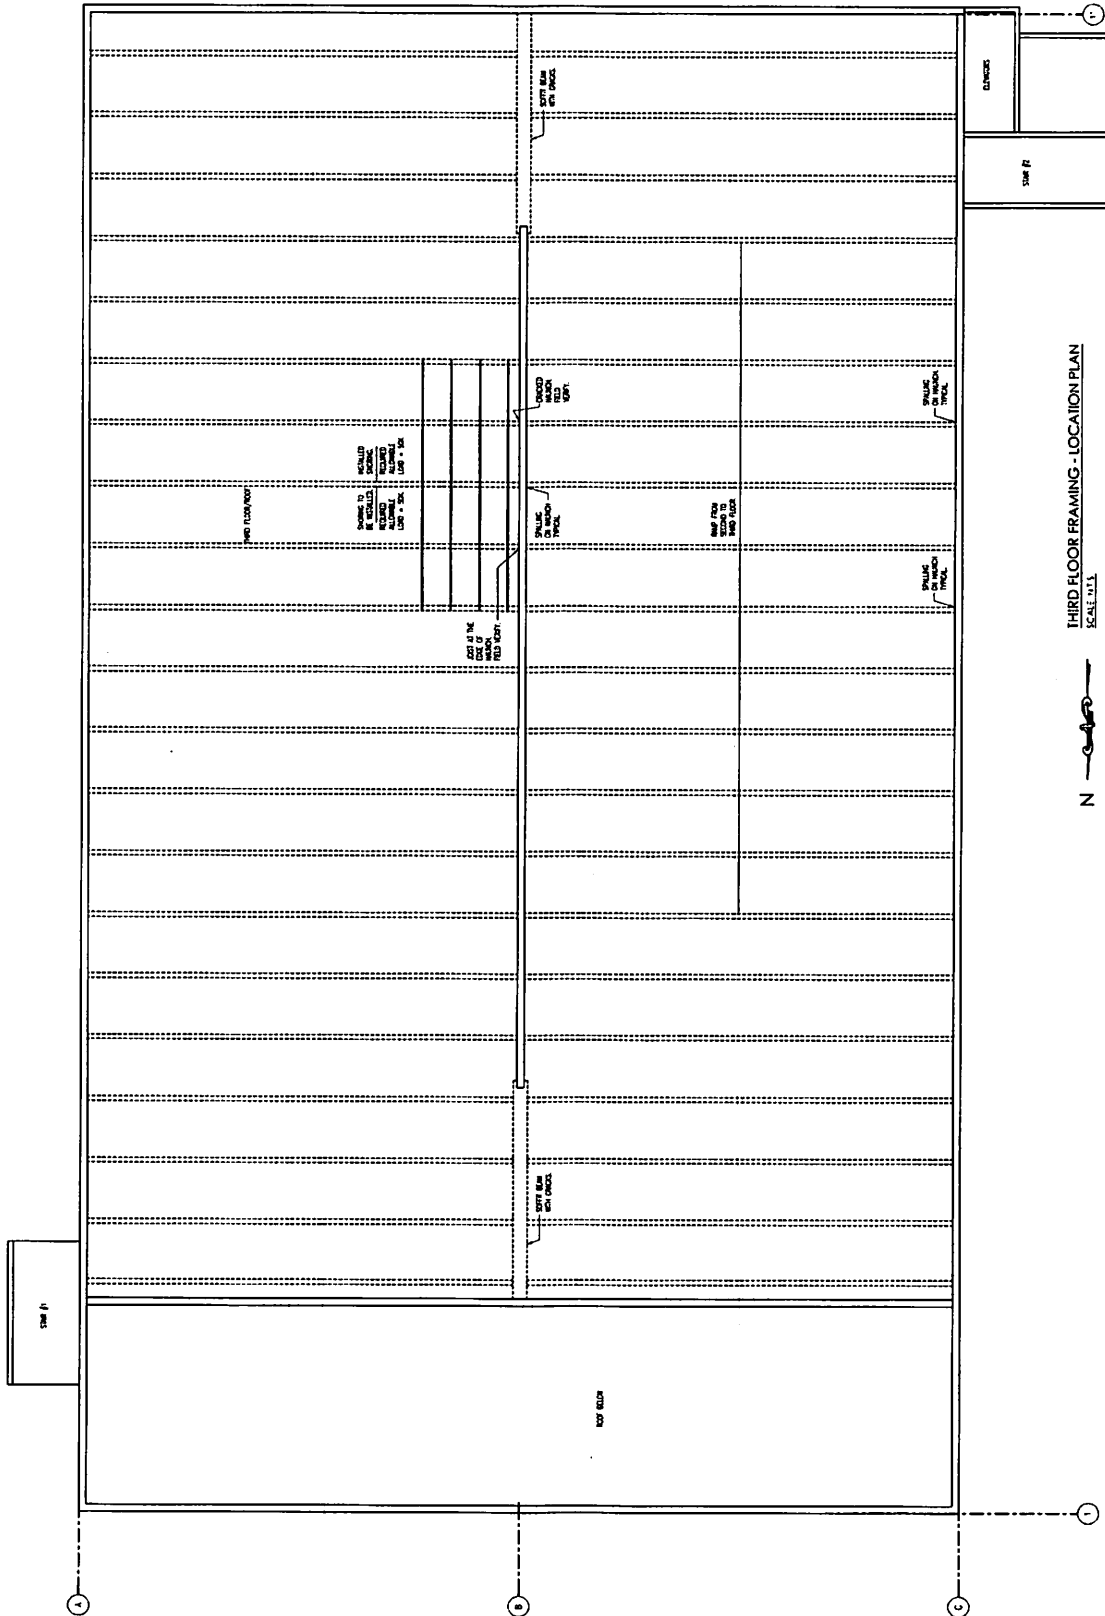
U.S. Postal Service™
CERTIFIED MAIL® RECEIPT
Domestic Mail Only
