Re: Edgar P. Mills Multi-Purpose Center – Parking Garage
Broward County, Florida

NOTICE OF CLAIM PURSUANT TO CHAPTER 558, FLORIDA STATUTES

Re – Edgar Mills Complex – Parking Garage, 900 NW 31st Avenue, Fort Lauderdale, FL:

Observed crack at a second-floor joist support – Field Report:

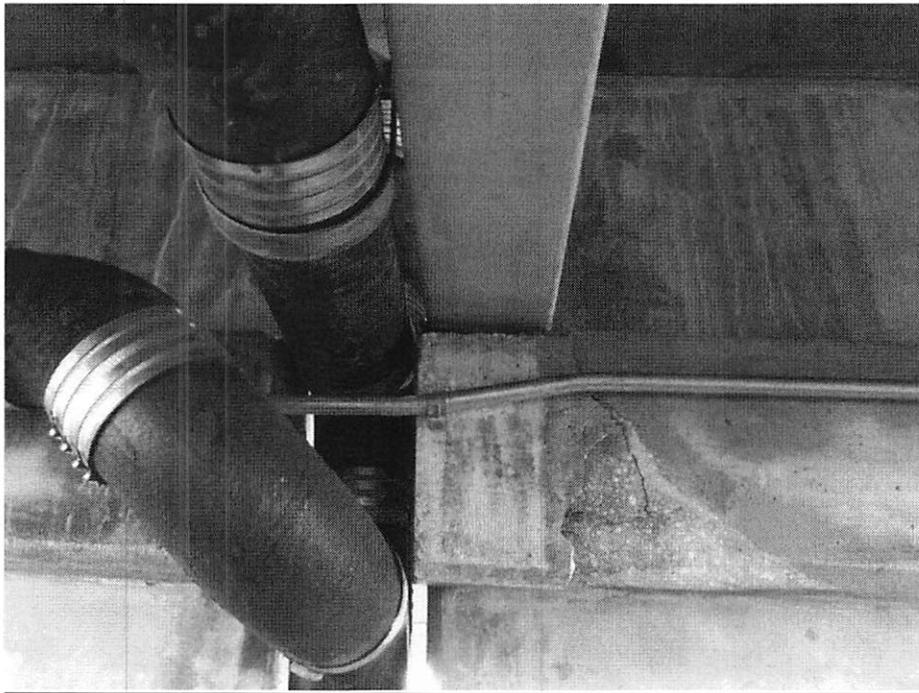
- 2) Second-Floor Haunch Crack: Below the West end of a third-floor joist (8th joist counting from the South Entrance) on the East wing of the garage, supporting haunch has failed as shown in the attached exhibits 1 through 4. Currently only the back end of the haunch may be providing any support to this joist. There is no bearing of the joist toward the face of the haunch as shown on exhibits 10 and 11. This joist is currently supported with temporary shoring extending to the ground floor slab as shown on exhibits 4 to 8. The Garage is currently closed, and no vehicles are parked inside.

The failed third floor haunch is at the edge of a concrete wall panel. We can see that the longitudinal rebar and the stirrups are located too far inside the haunch, with about 3" concrete cover. It is important to locate the reinforcing close to the face of the haunch to prevent the unreinforced concrete along the edges to fail in shear. This is exacerbated by the fact that at this location, the joist is supported at the end of the haunch. This creates a situation where the haunch is in single shear versus the typical condition of double shear, essentially reducing the shear capacity by half. We believe that these are the possible causes for the shear failure observed.

Exhibit 1: Cracked Haunch below third floor joist.

We believe that the installed shoring below the third-floor joist, continuous to the ground floor is adequate to temporarily support this joist at the cracked haunch. We recommend similar shoring at a similar condition which is occurring on the second joist to the North of the cracked haunch as shown on exhibit 9.

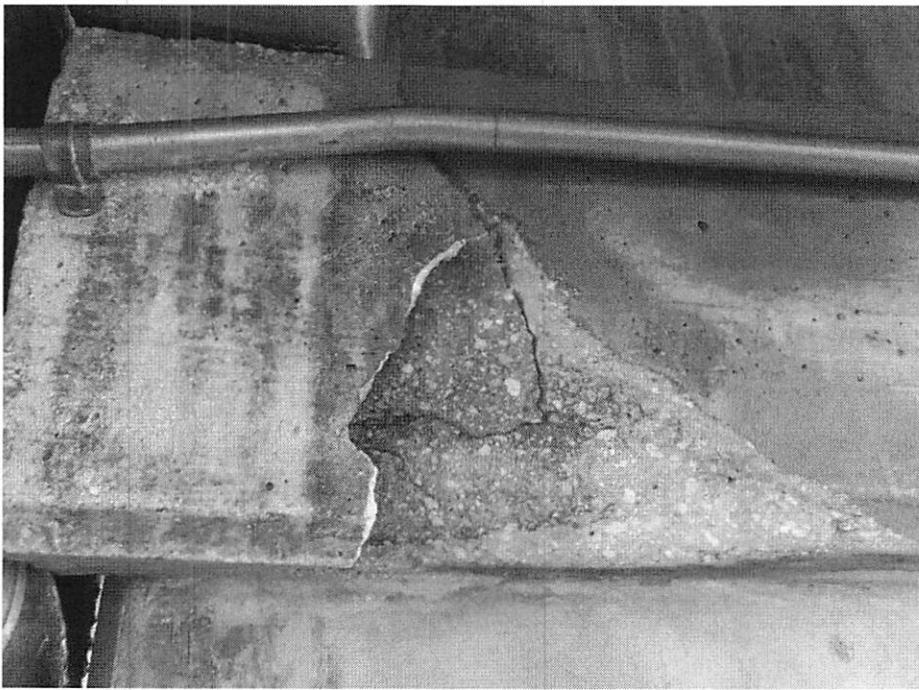
Exhibit 2: Cracked Haunch below third floor joist. No stirrups found in this area.

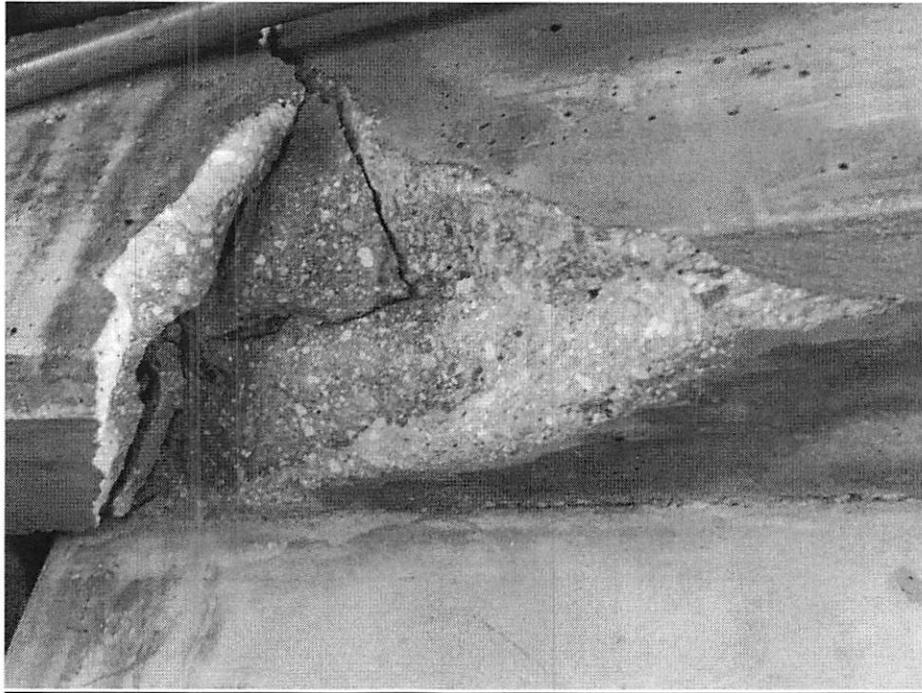
Exhibit 3: Cracked Haunch below third floor joist – No longitudinal rebar found here.

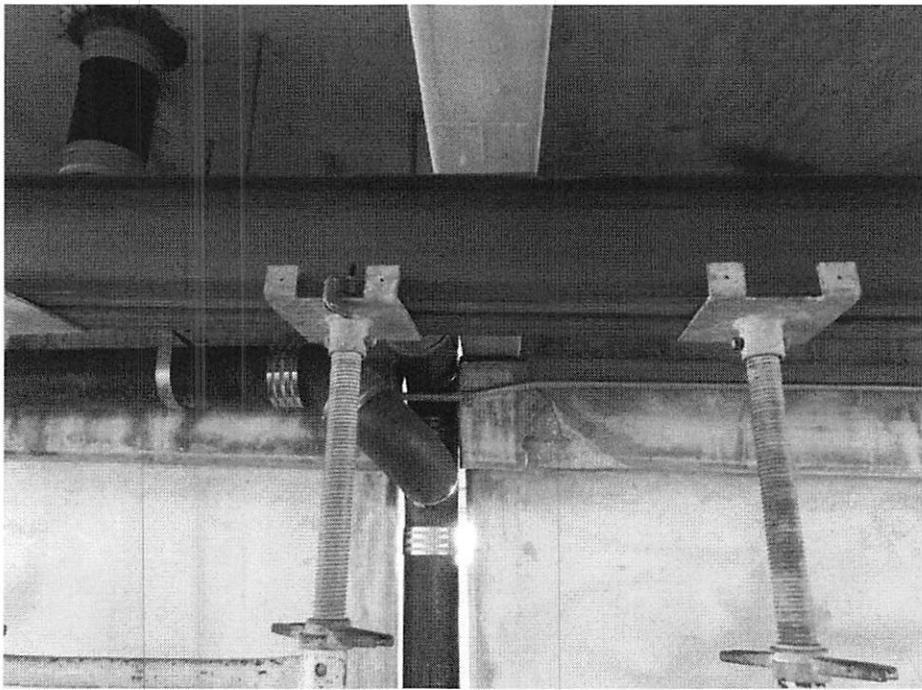
Exhibit 4: Cracked Haunch and Shored Joist below third floor.

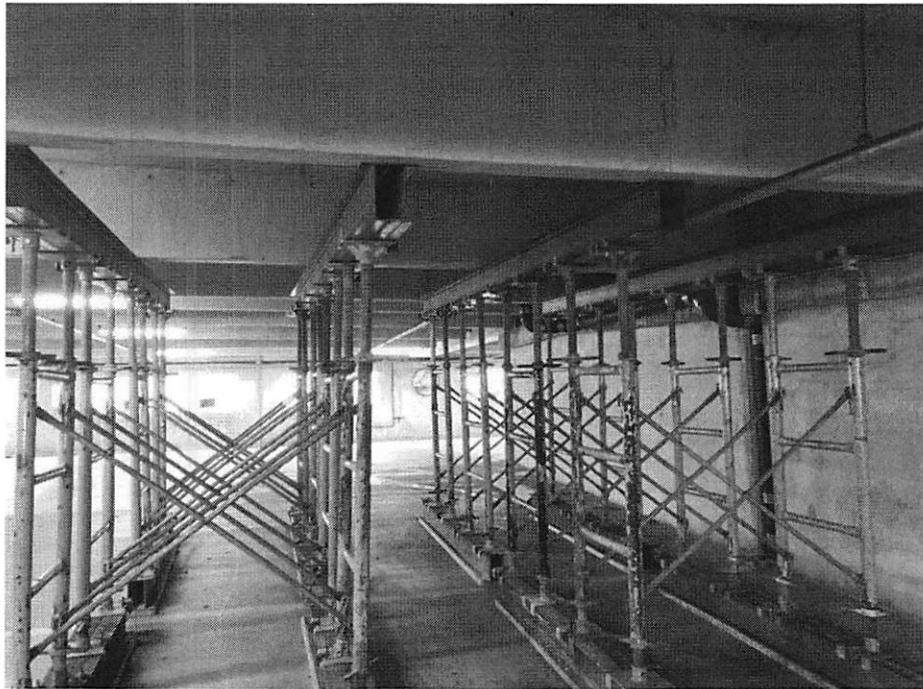
Exhibit 5: Overall view of the shoring on second floor.

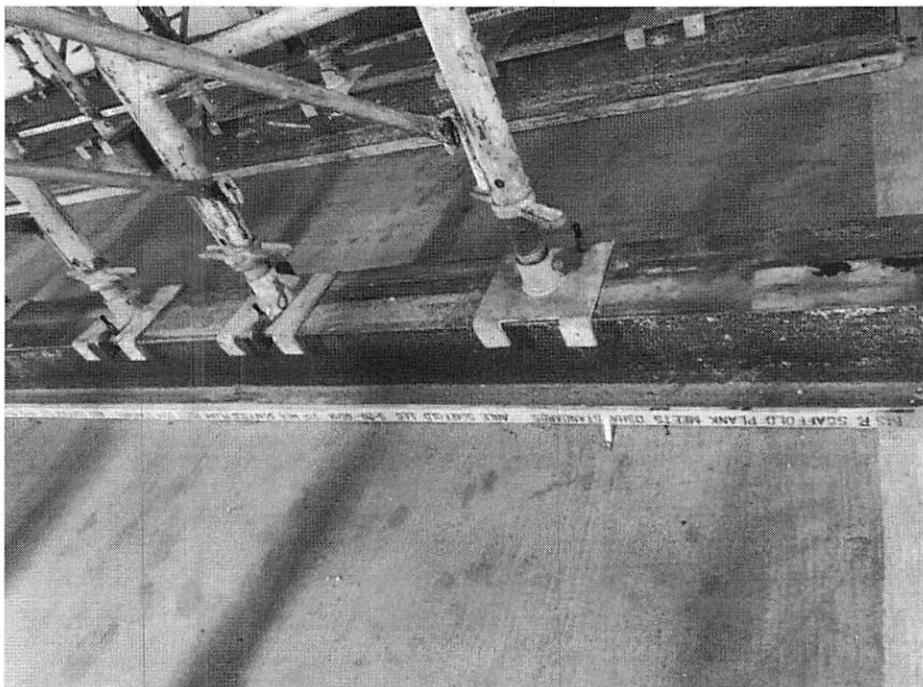
Exhibit 6: Spreader beam and post attachment at the shoring towers.

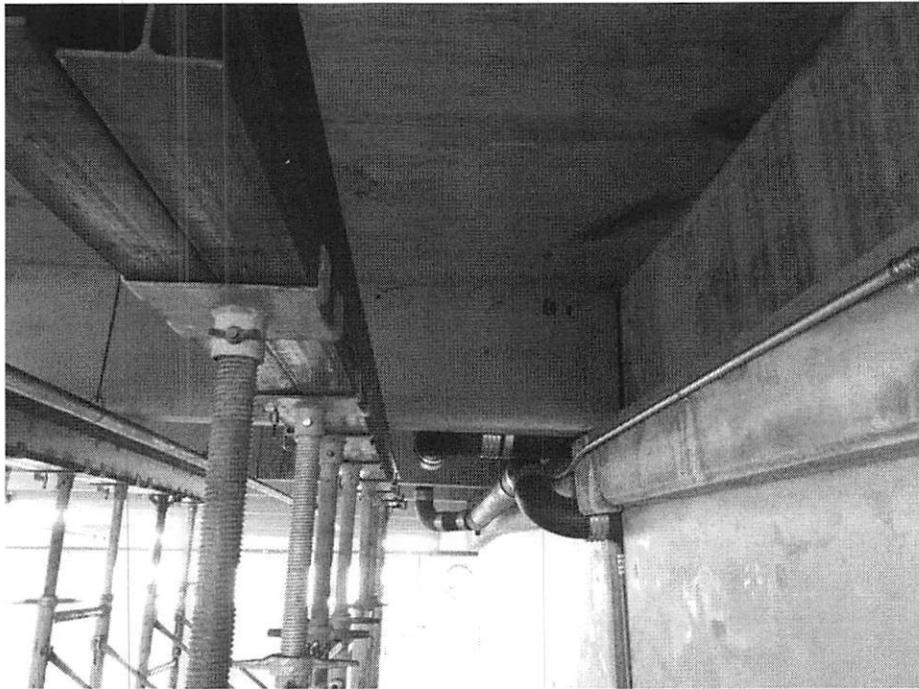
Exhibit 7: Steel beam and shoring detail at the top of shoring towers.

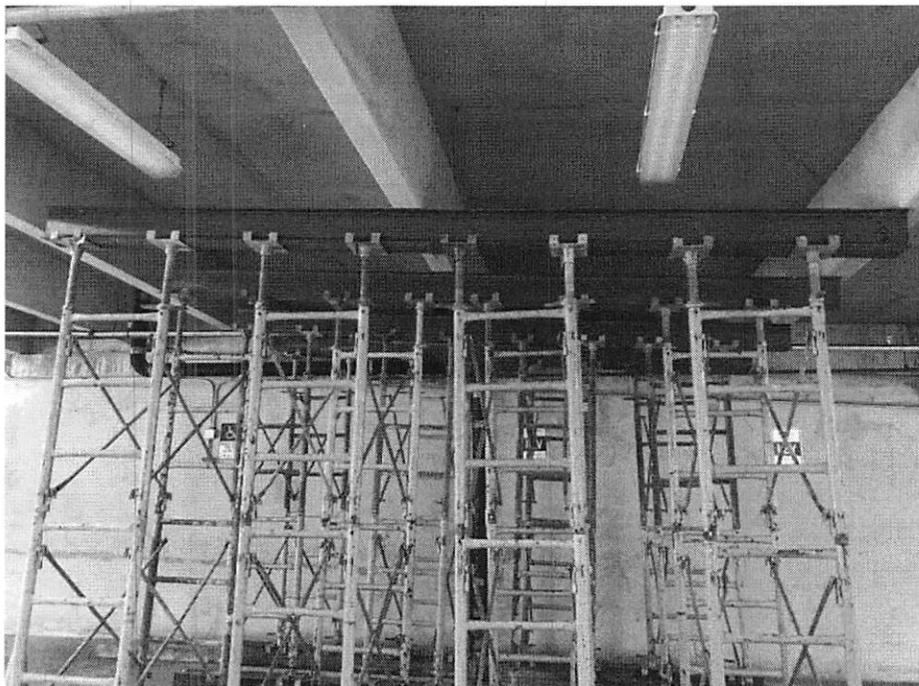
Exhibit 8: Overall view of the shoring on ground floor.

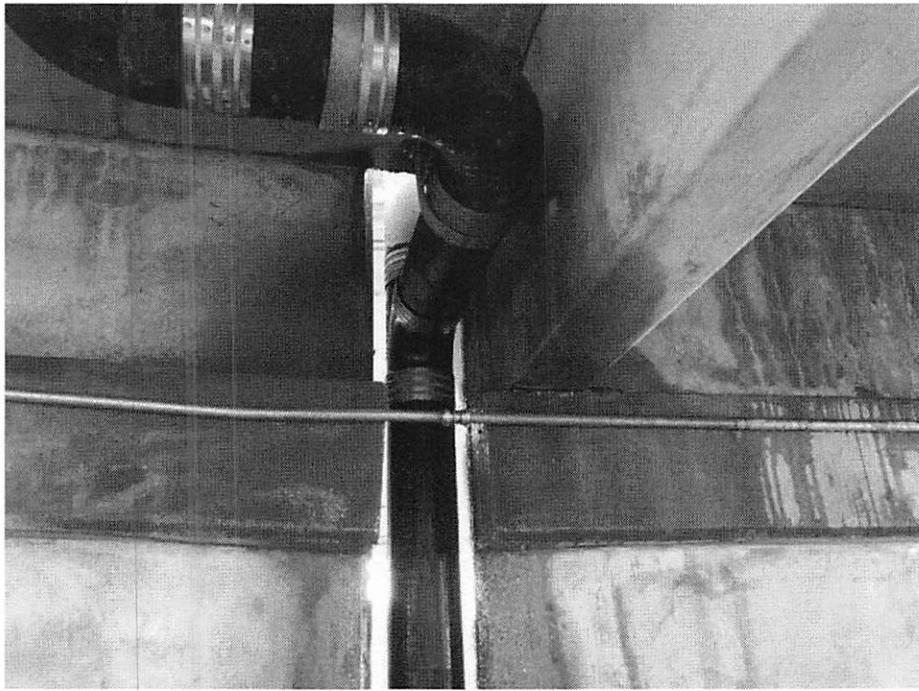
Exhibit 9: Condition where a third floor joist is at the edge of a haunch. Shoring is required here.

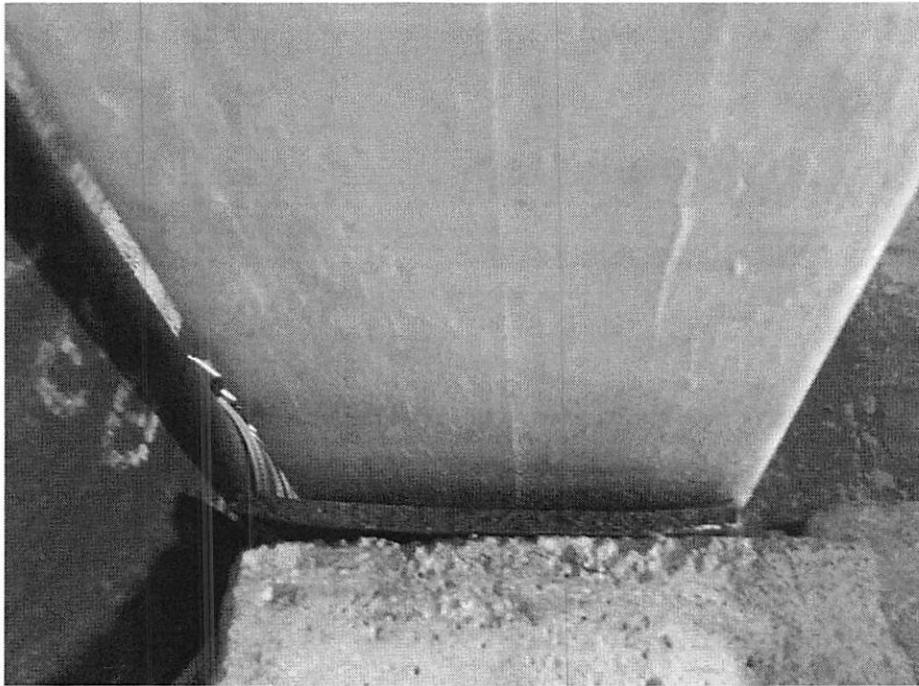
Exhibit 10: Loose bearing pad. Joist is not bearing on the front half of the cracked haunch.

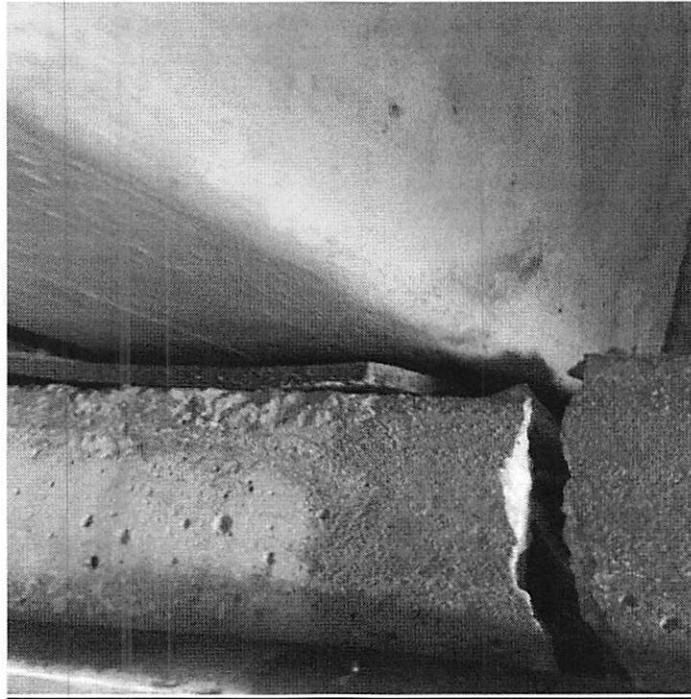
Exhibit 11: Loose bearing pad. Joist is not bearing on the front half of the cracked haunch.

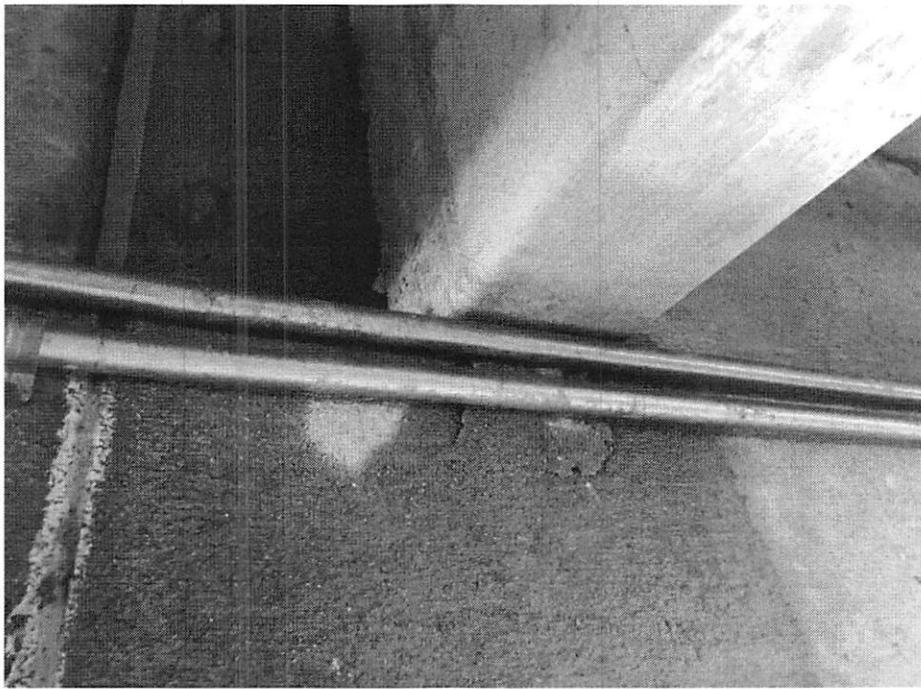
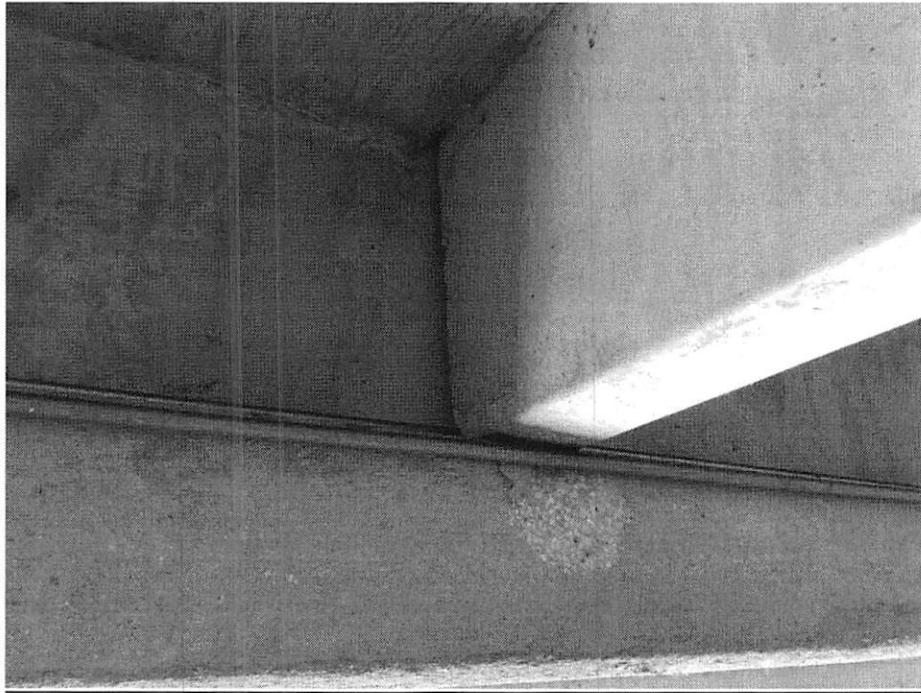
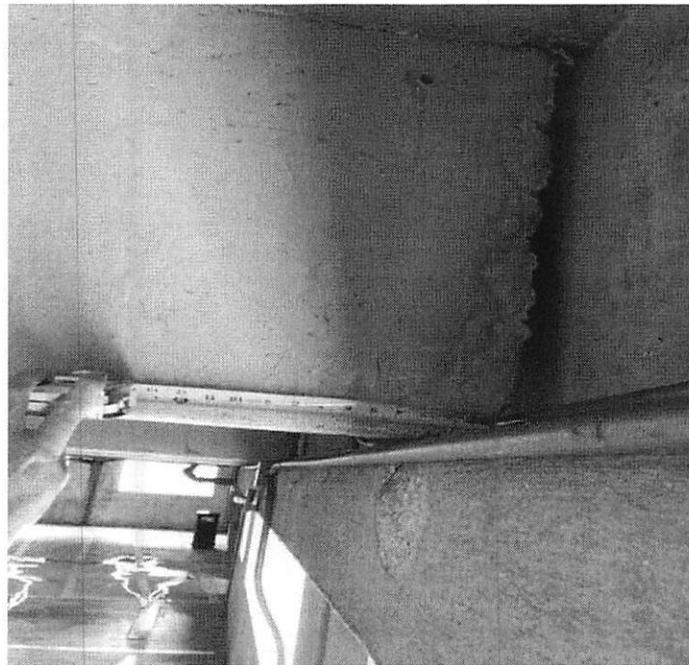
- 3) Cracks and Spalls on the face of haunches at other locations: We observed cracks and spalling on the face of haunches at other locations as shown on exhibits 12 to 14. These are occurring primarily below the roof joists.

We believe that the relatively smaller spalling and cracking at the faces of the haunches at other locations are due to the flexing of the joists up and down due to the temperature variations which are more severe for the joists below the exposed roof slabs.

Exhibit 12: Spalled face of a haunch below a supported joist.

Exhibit 13: Spalled face of a haunch below a supported joist.

Exhibit 14: Spalled face of a haunch below a supported joist.

We believe that the garage can be opened after installing this shoring and protective barricade around the shoring. This shall be followed by a complete review of the structural drawings and permanent repairs of the observed spalling and cracking at the haunches, soffit beams and slabs.

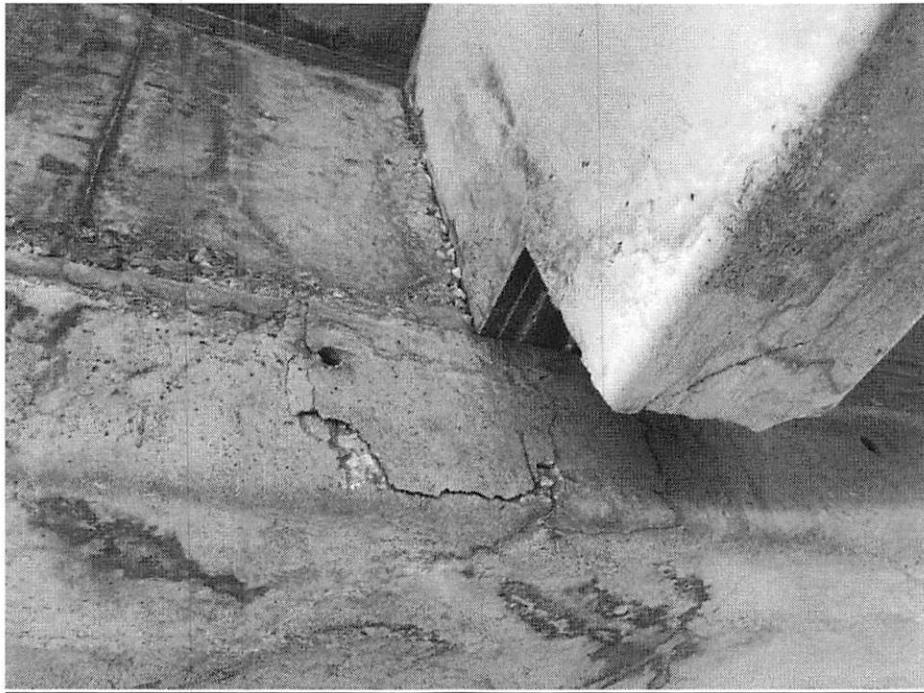
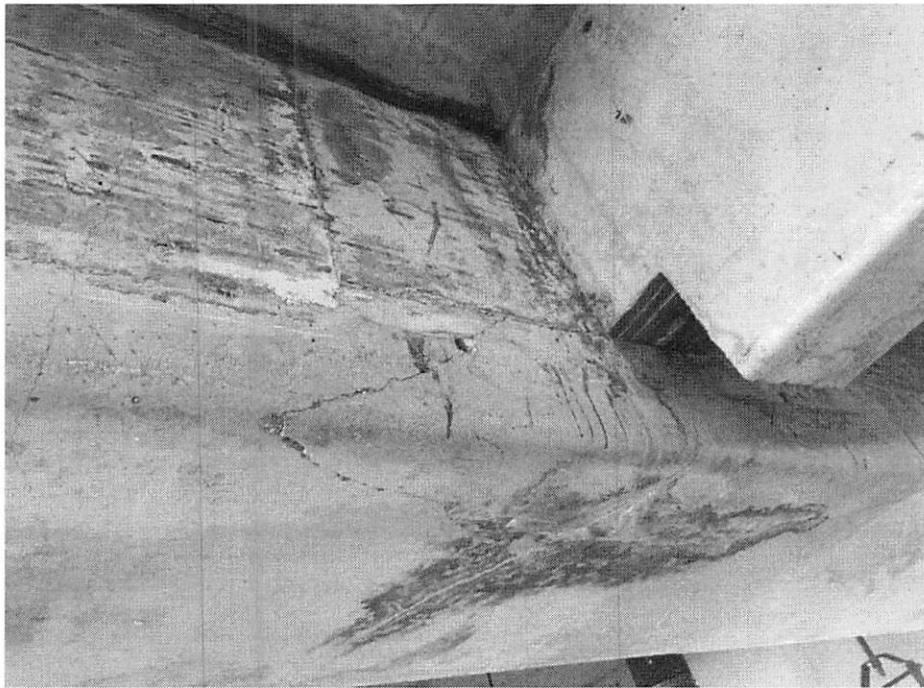
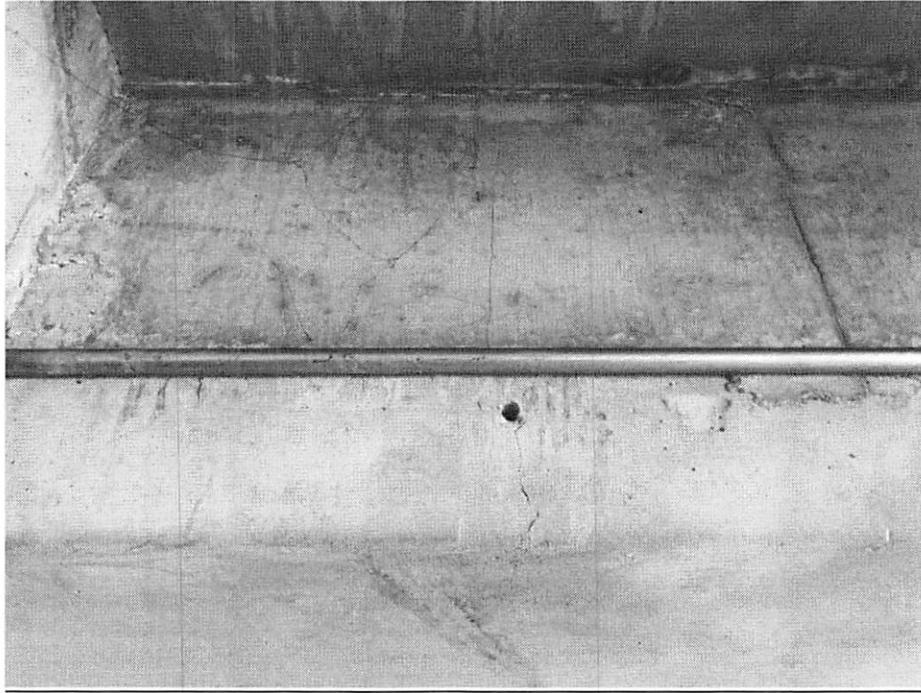
- 4) Cracks on Soffit Beams: Cracks are found on the soffit beams at the North end and South end as shown in the exhibits 15 to 17. Cracks are vertical cracks and diagonal cracks and also cracking below supported joists.

We believe that the soffit beam cracks below the supported joists are due to the flexing of the joists up and down due to the temperature variations which are more severe for the joists below the exposed roof slabs. Other vertical and diagonal cracks appear to be stress cracks due to the applied loading.

Exhibit 15: Spalling and Cracking on a soffit beam at a joist support.

Exhibit 16: Spalling and Cracking on a soffit beam at a joist support.

Exhibit 17: Vertical and diagonal cracks on a soffit beam.

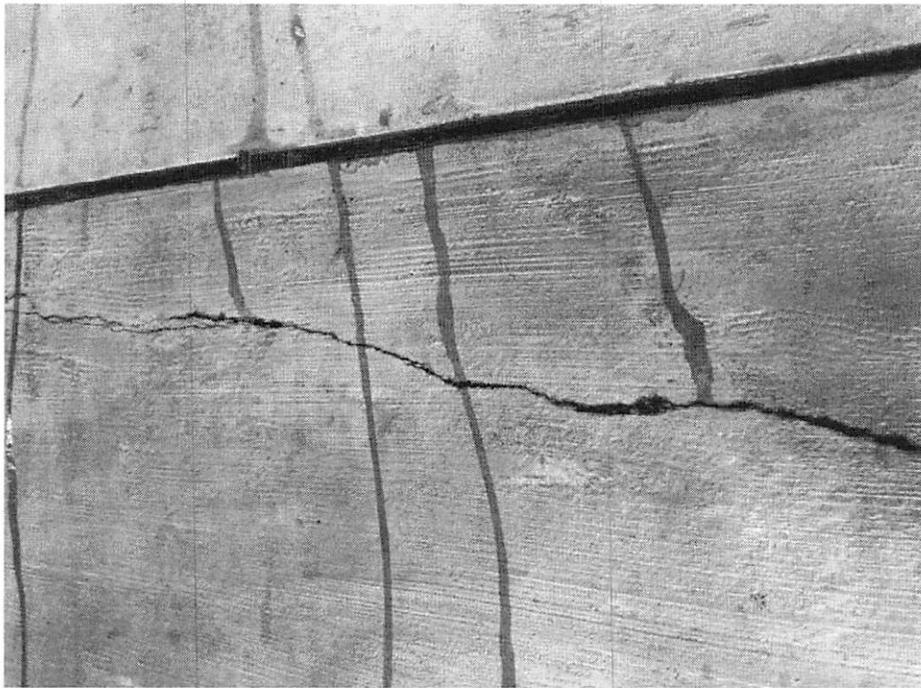
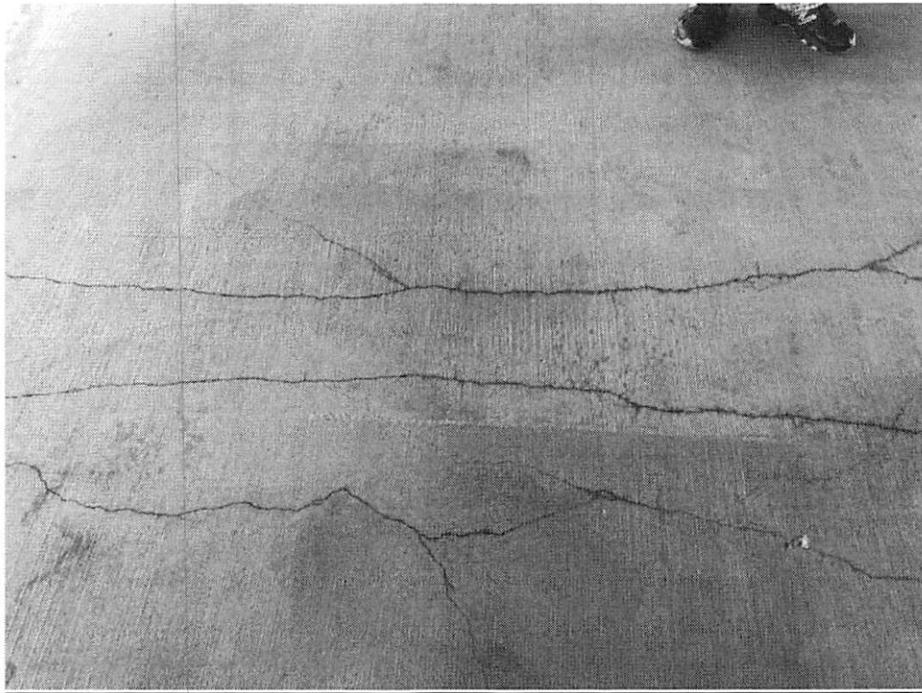
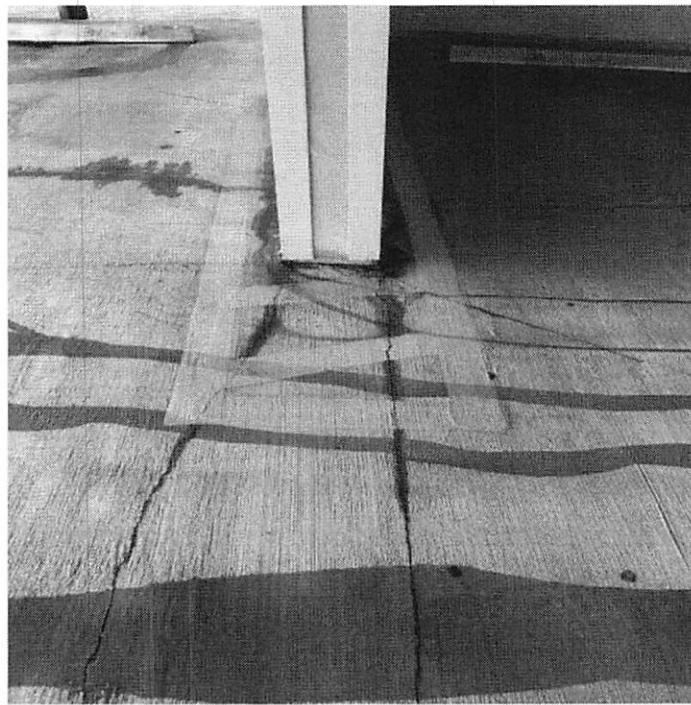
- 5) Concrete Slab Cracks: There are widespread cracking on concrete slab. Cracks are also noted along the top of soffit beams as shown on exhibits 18 to 20.

Topping slab has widespread cracks as noted above. It appears that these are primarily shrinkage cracks. We also observed cracks due to negative moments along the top of soffit beams.

Exhibit 18: Slab cracks along the sides of a soffit beam.

Exhibit 19: Slab cracks along the sides of a soffit beam.

Exhibit 20: Slab cracks along the sides of a soffit beam.
