CB Smith Park 900 N. Flamingo Road Pembroke Pines, FL 33028 January 10, 2023

Ref: Broward County Florida; PRA 2101163

Champion Industrial Report

Findings under applied gel coat surface

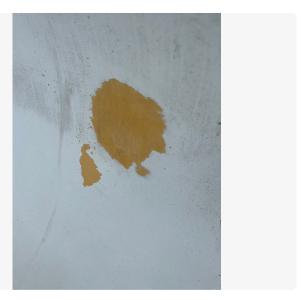
1

Findings on site, we sanded multiple locations across each slide. As the photo's below indicate there was improper preparation/sanding present which is the cause of previously applied gelcoat not adhering. Due to lack of proper preparation this gelcoat layer could potentially continue to peel if not removed. Our recommendation would be to completely remove the entire layer and get back to factory gelcoat prior to resurfacing.

Spot in yellow slide, scraped off with a 5-1 multi tool.

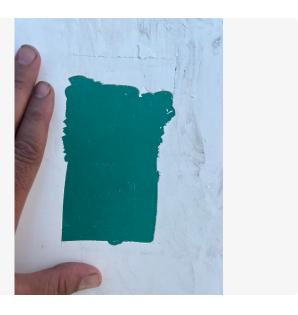
3

Spot in Green slide same issues. Very few sanding marks

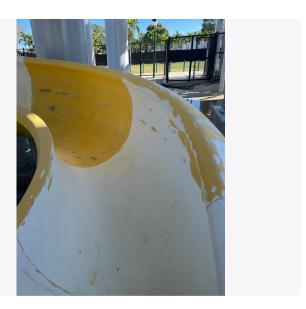
1

We timed 2 sections back to back to estimate the amount of time it will take compared to our normal preparation. Our standard section takes on average 15 min, the fully stripped section took just under 1.5 hour.

As you can see in the stripped section it is back down to factory gel coat and we can guarantee proper adhesion. However by being more aggressive with the sanding this will run into the issue of exposing more bare fiberglass, which will also require more body work. Bare fiberglass is porous in nature and will require mastic body filler.
